November 18, 2010

New Satellite Imagery of Yongbyon Shows Construction Progress on Experimental Light Water Reactor

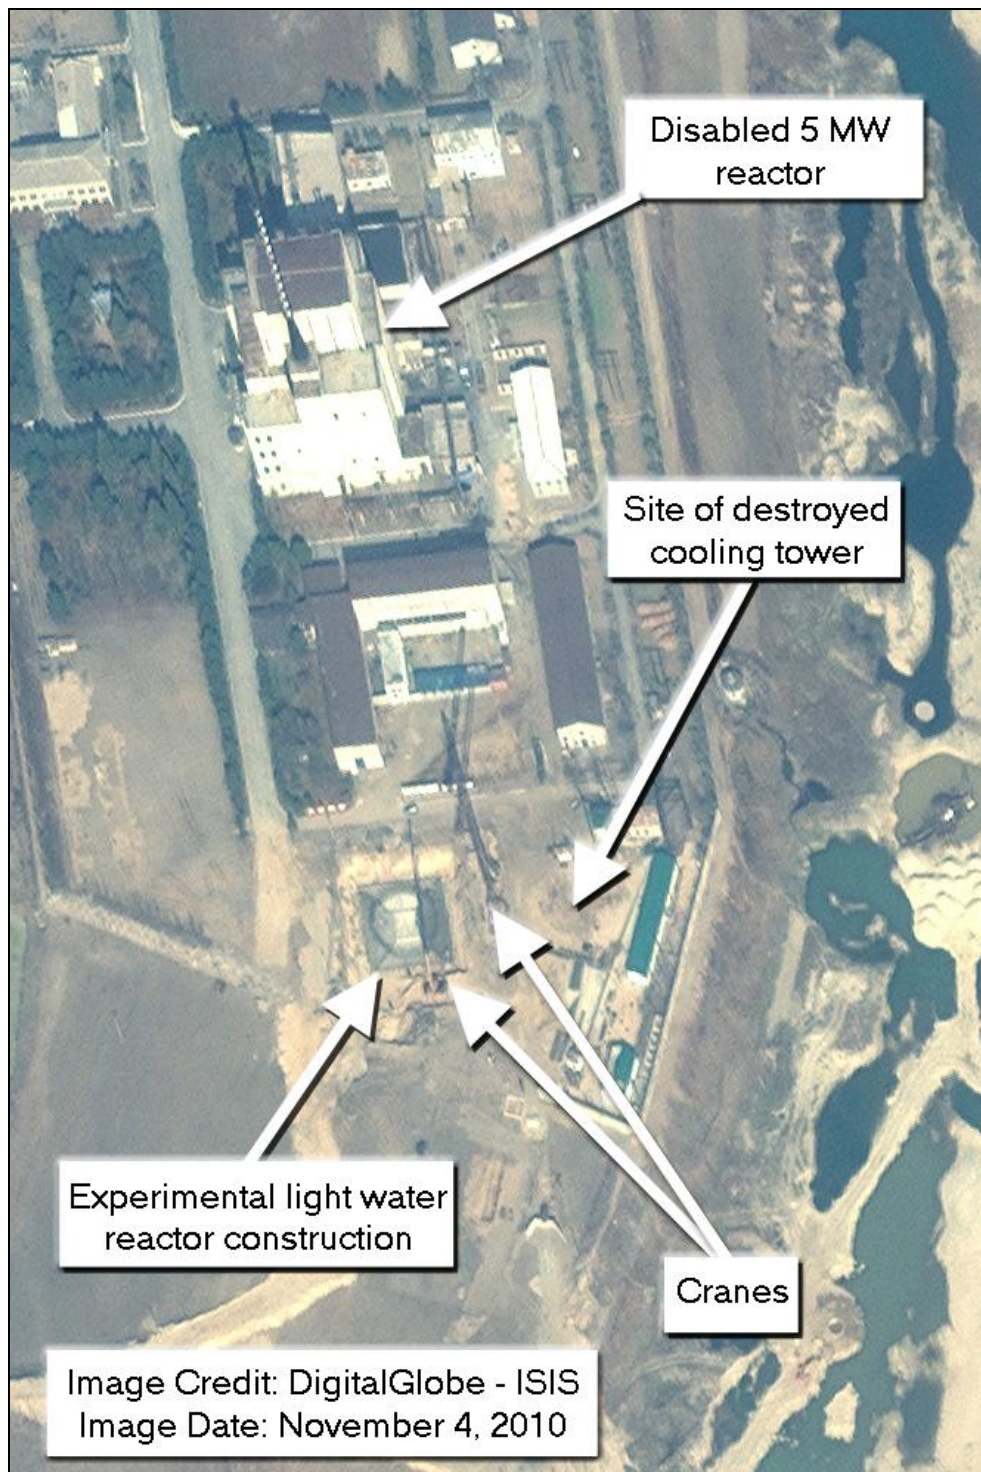
Figure 1. November 4, 2010 DigitalGlobe satellite image of the Yongbyon nuclear site showing continuing construction at the site the destroyed cooling tower for the original 5MW reactor. Dr. Sigfried Hecker informed ISIS that this is the same site where construction of a new experimental light water reactor is taking place.

ISIS has obtained commercial satellite imagery from DigitalGlobe of the Yongbyon nuclear site in North Korea taken on November 4, 2010. The imagery shows that construction activity at the site of the destroyed cooling tower¹ for the disabled 5 MWe reactor is progressing (see figure 1). The frame of a large building can now be seen, where [ISIS reported](#) that commercial satellite imagery from September 29, 2010 showed only excavation (see figure 2). Dr. Siegfried Hecker and Ambassador Jack Pritchard, upon their return from a recent visit to Yongbyon, [reported](#) that North Korea is building a 25-30 megawatt-electric (MWe) experimental light water reactor at the Yongbyon nuclear site. Dr. Hecker informed ISIS that the new construction seen in the satellite imagery is indeed the construction of the experimental light water reactor.

The November 4, 2010 imagery shows a rectangular structure being built. At least two cranes are visible in the imagery (see figure 1). In constructing the experimental light water reactor at the site of the destroyed cooling tower, North Korea may intend to utilize existing infrastructure for the new reactor. For example, it could use water piping for the secondary cooling system of the 5 MWe reactor that remained after the disablement process of this reactor.

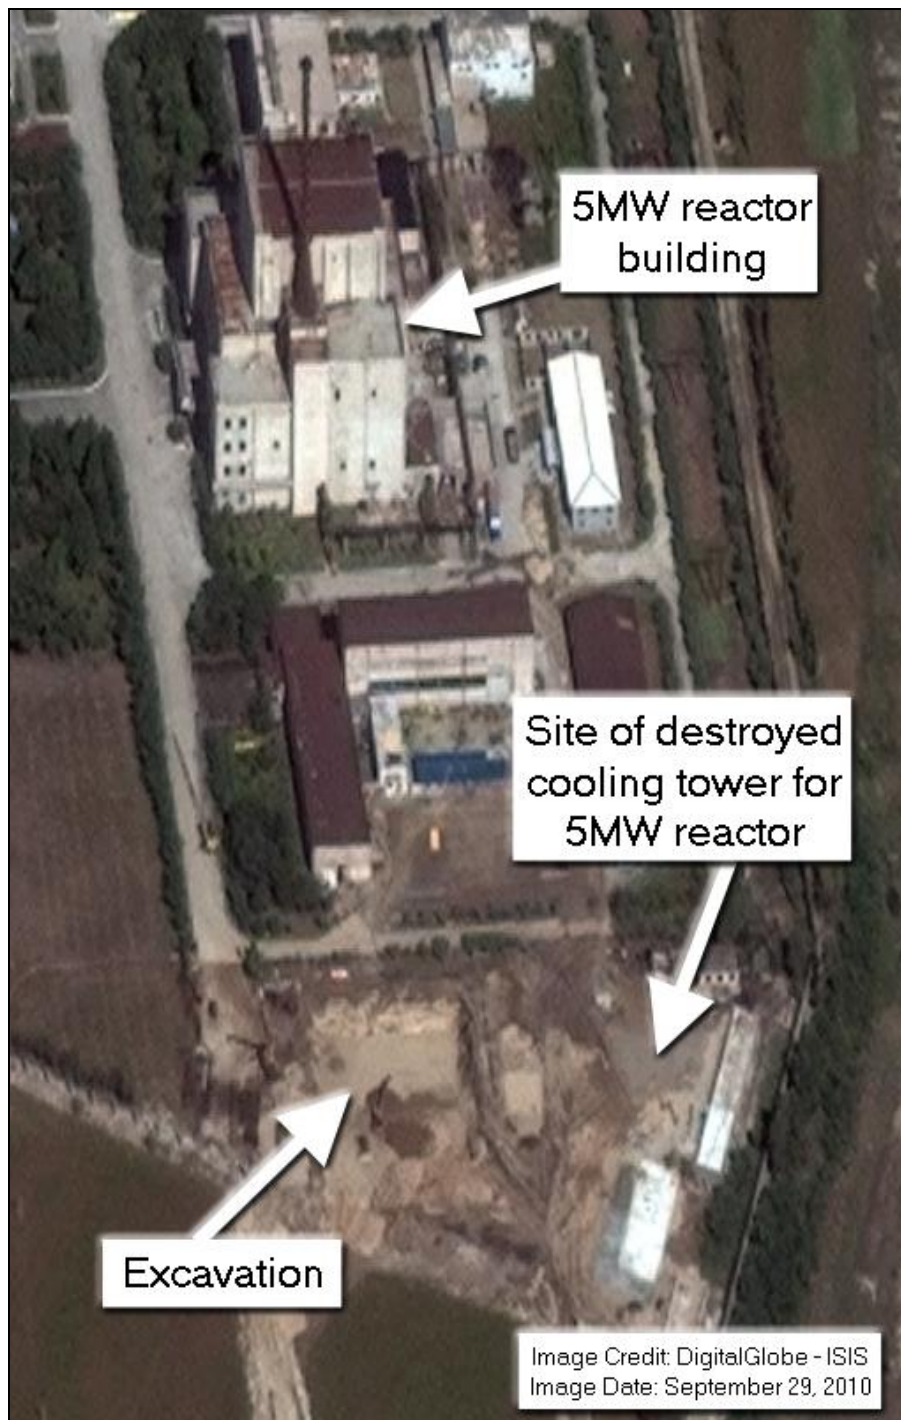
Figure 2. September 29, 2010 DigitalGlobe satellite image of the Yongbyon nuclear site showing excavation activity in the area of the destroyed cooling tower.
